March 3, 2022

**RE: Draft Maine DEP Water Quality Certification for the Hiram Hydroelectric Project # L-07780-33-L-N, FERC Docket P-2530**

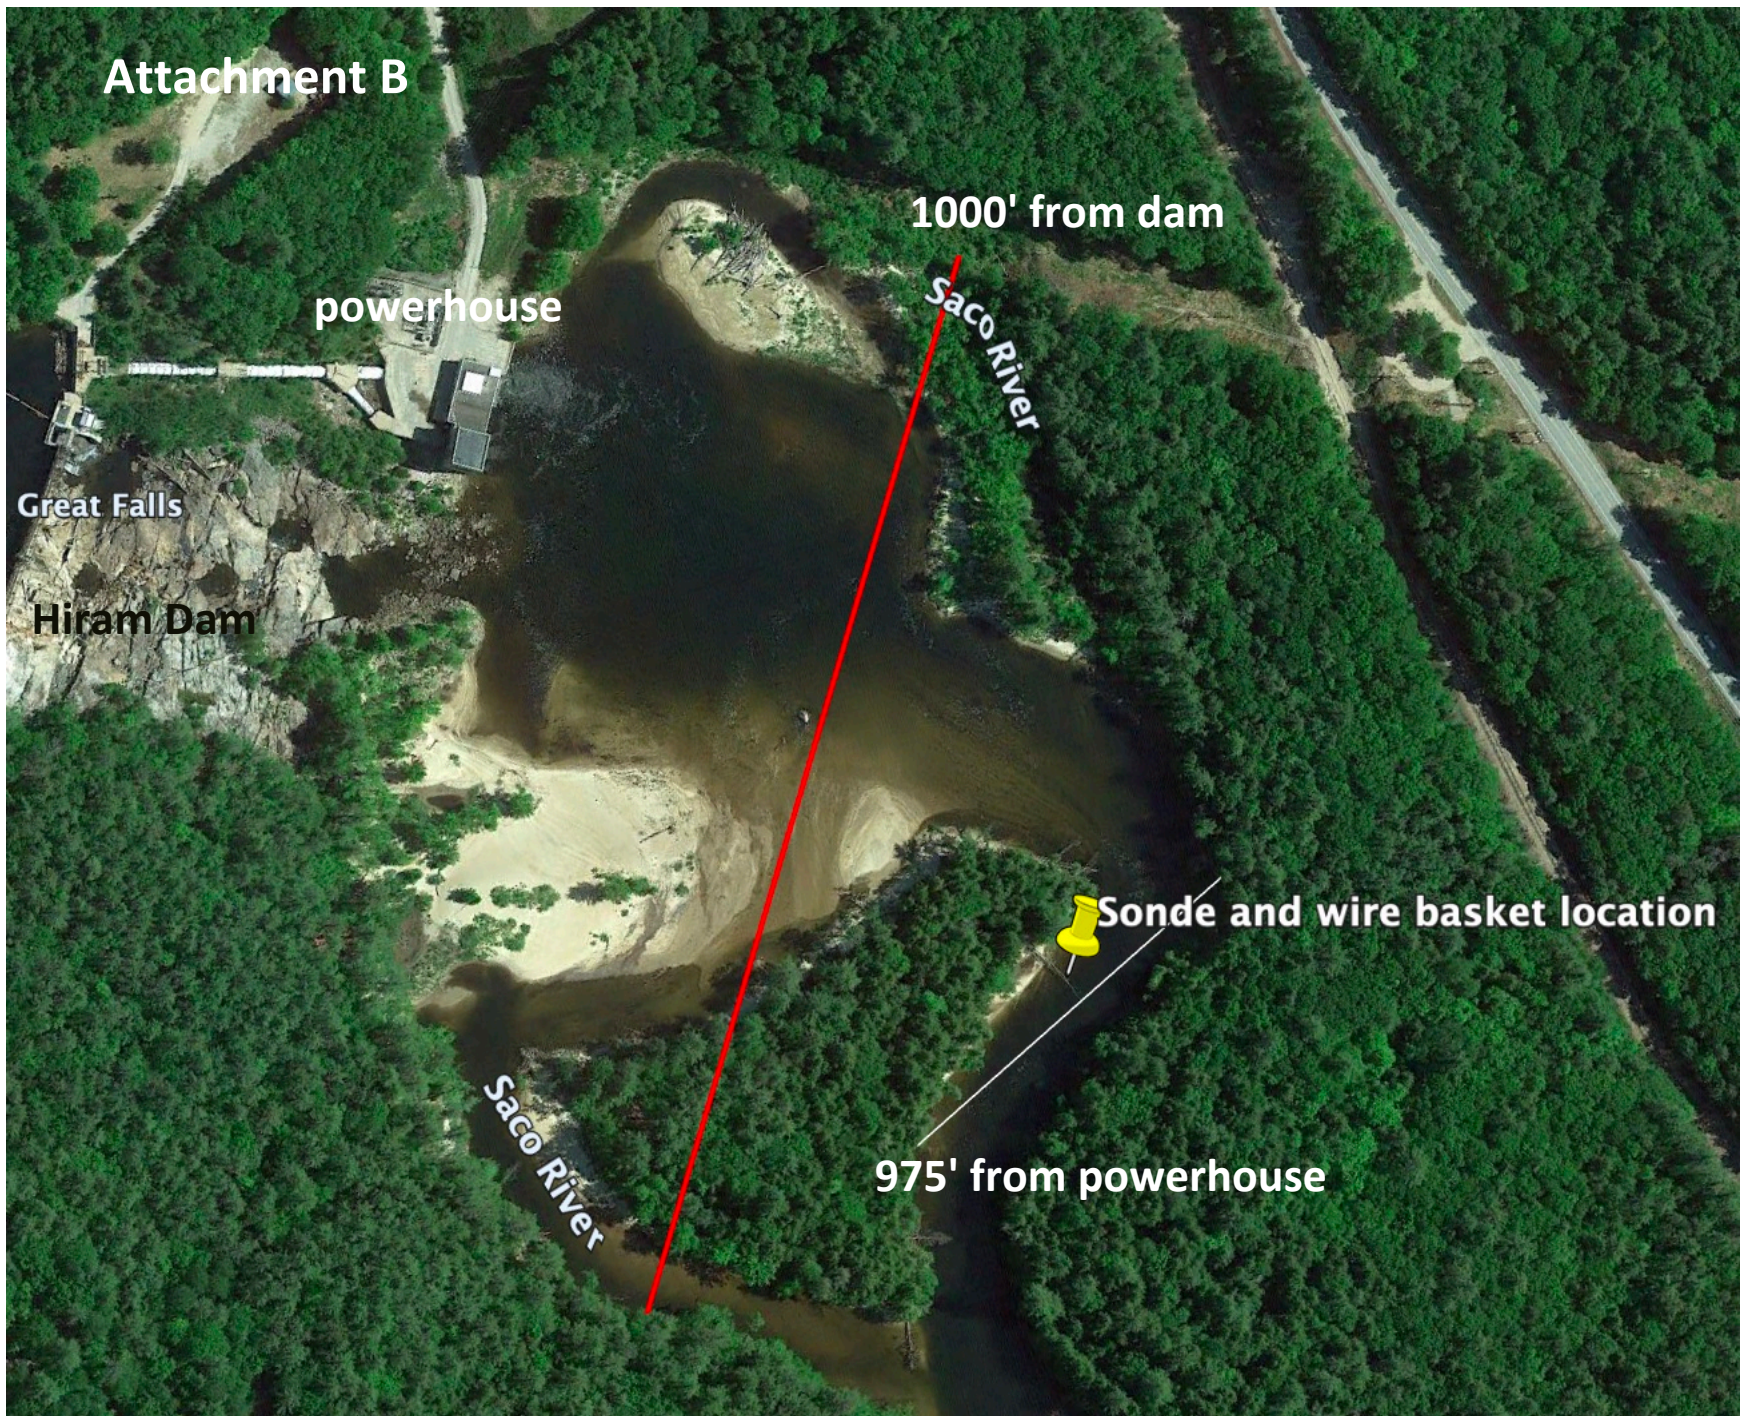
**Attachment B**

powerhouse

1000' from dam

1000 feet below the base of Hiram dam - the Class A area - extends only to a point about 500 feet below the powerhouse. Thus, **975 feet downstream of the powerhouse is well beyond the Class A area and in the Class AA waters.** It is unclear whether the Applicant chose this location to sample to get a more favorable result or simply misinterpreted the plain language of the statute. In any event it appears to be in the wrong location. For clarification, we have provided Attachment B which illustrates the demarcation of Class A and AA waters relative to the Hiram Dam and powerhouse. In the absence of other interpretations, we must assume that the statute means what the plain language of the statute says: that the Class A waters extend from Hiram Dam itself, not the powerhouse.

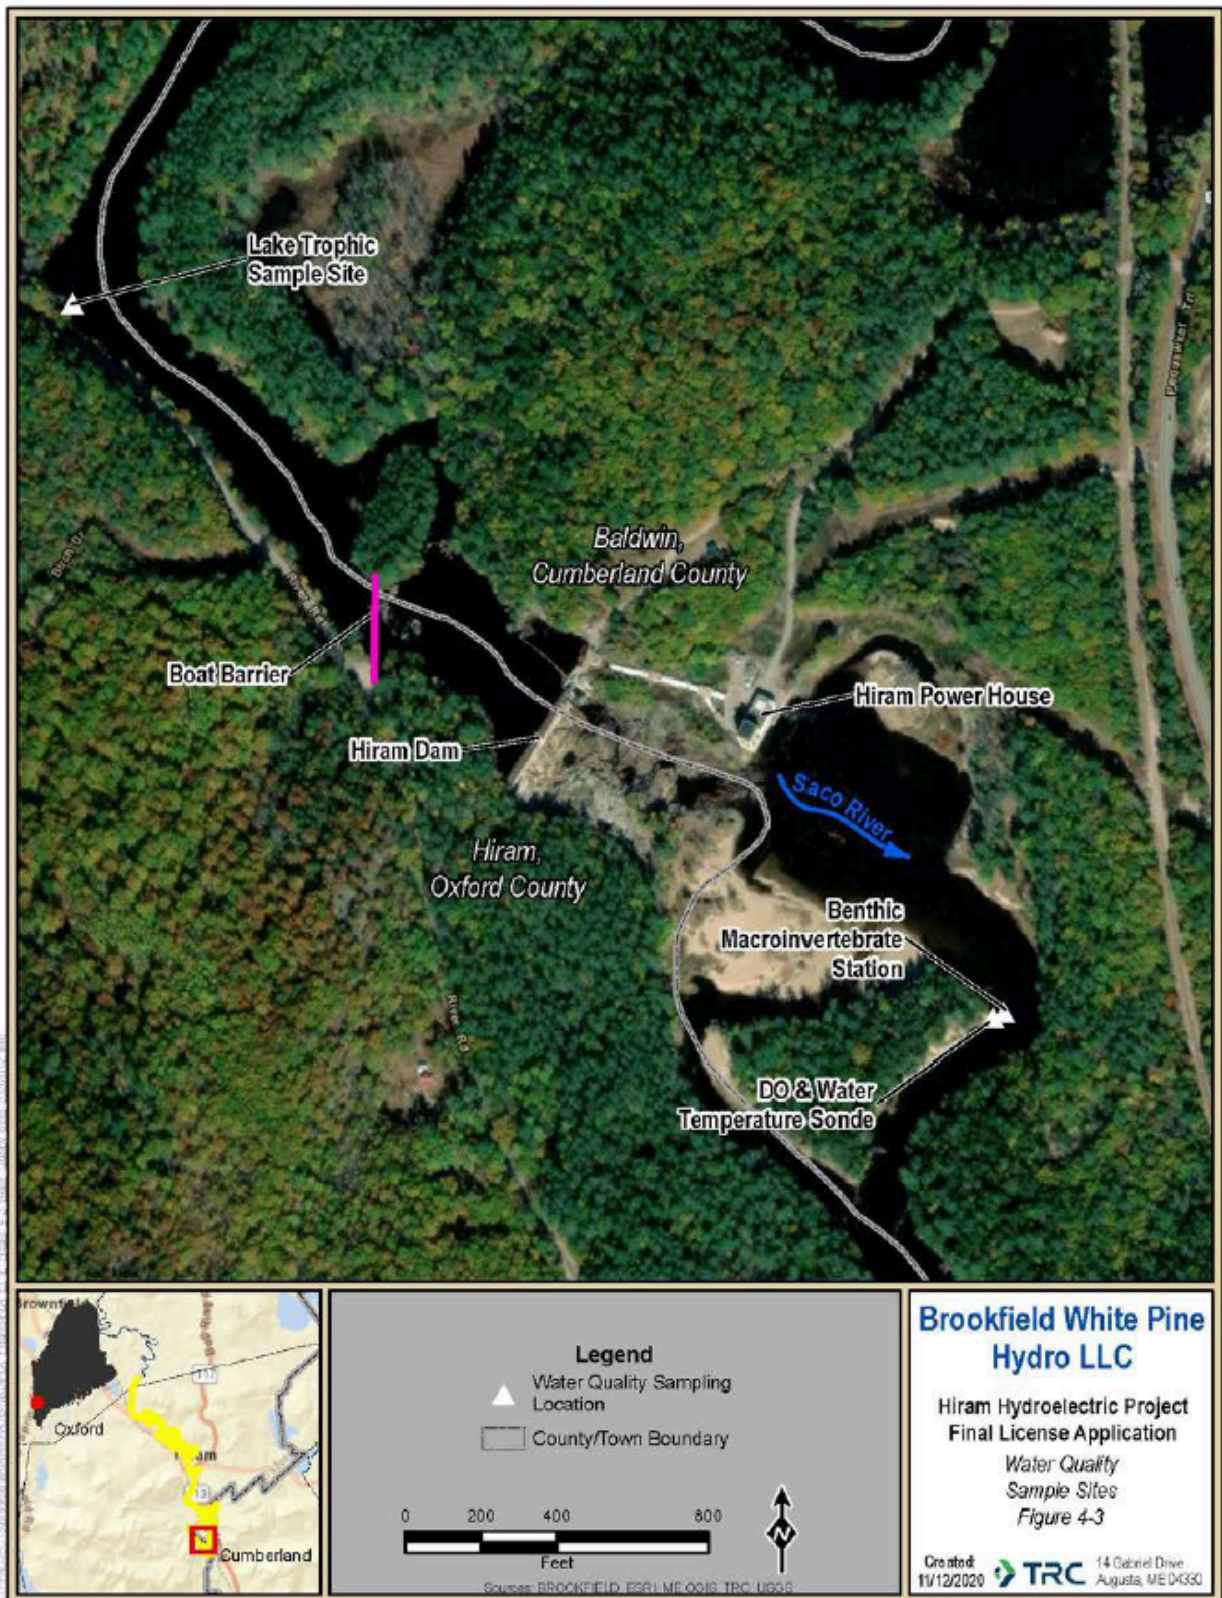
# Attachment D

FIGURE 4-3 2018 WATER QUALITY STUDY SAMPLE SITES

This clearly defines the area of primary concern to be entirely in the plunge pool located below the powerhouse per Attachment D.<sup>25</sup> Water with similar characteristics should have been the site of evaluation, yet instead of sampling in the plunge pool, the data submitted was in waters on a point of land below it with different characteristics on a much narrower run of water. Scrutinizing the protocols, we found that sampler placement is to: **“Avoid bank effects: samplers should be located in the middle 50% of the bank to bank width, or in an area with a flow regiment typical of the overall character of the stream segment.”<sup>26</sup>** (Emphasis supplied) Attachment D also shows that the sampler was placed near the bank. Of additional note: we also discovered during our analysis that the field data sheet submitted for the macro-invertebrate study<sup>27</sup> provided as Attachment E shows the following Lat-Long Coordinates: 43° 39'52.49"N, 70° 36'03.27"W. This locates the samplers below the West Buxton Dam. While this makes exact location of the sampler impossible to determine, the Attachment F photograph<sup>28</sup> confirms that the Sonde was next to the west bank.

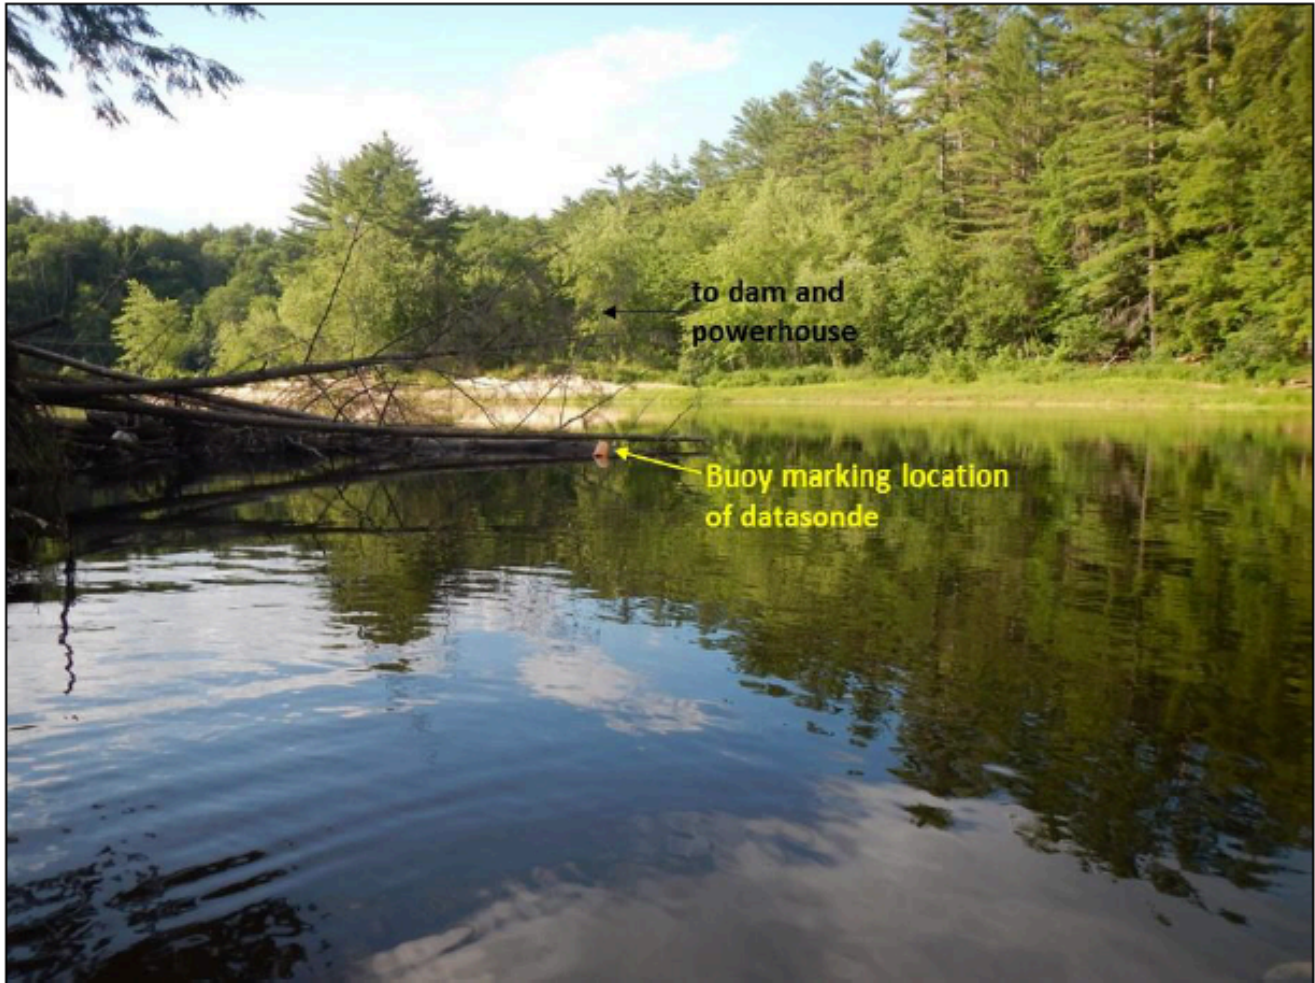
## Attachment F

**Photo 2.1-2: Location of datasonde downstream of Hiram Project**

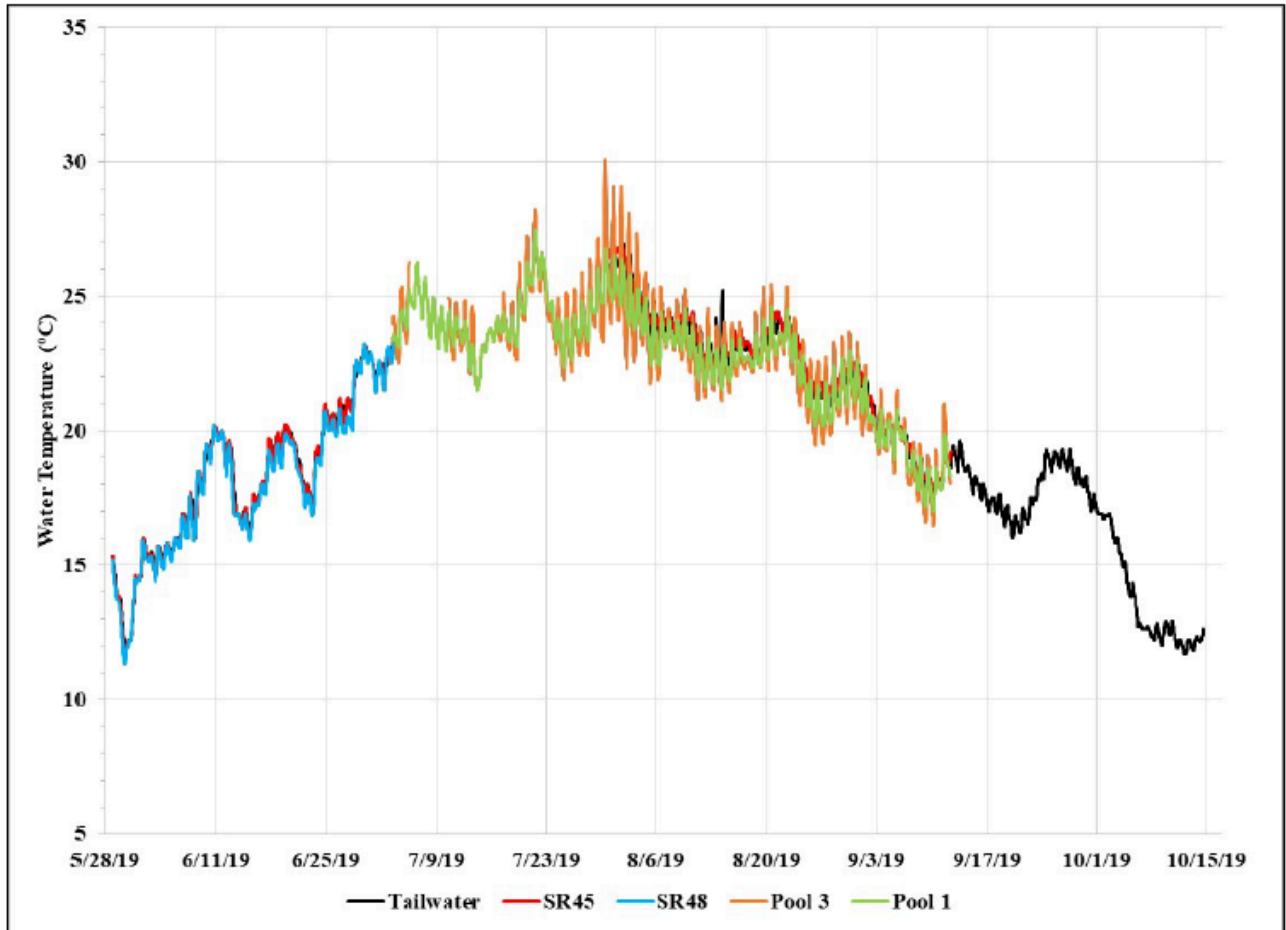
# Attachment G

**FIGURE 4-7 WATER TEMPERATURE FROM THE HIRAM IMPOUNDMENT AND TAILWATER AND THE HIRAM FALLS REACH, MAY 28 TO OCTOBER 14, 2019**

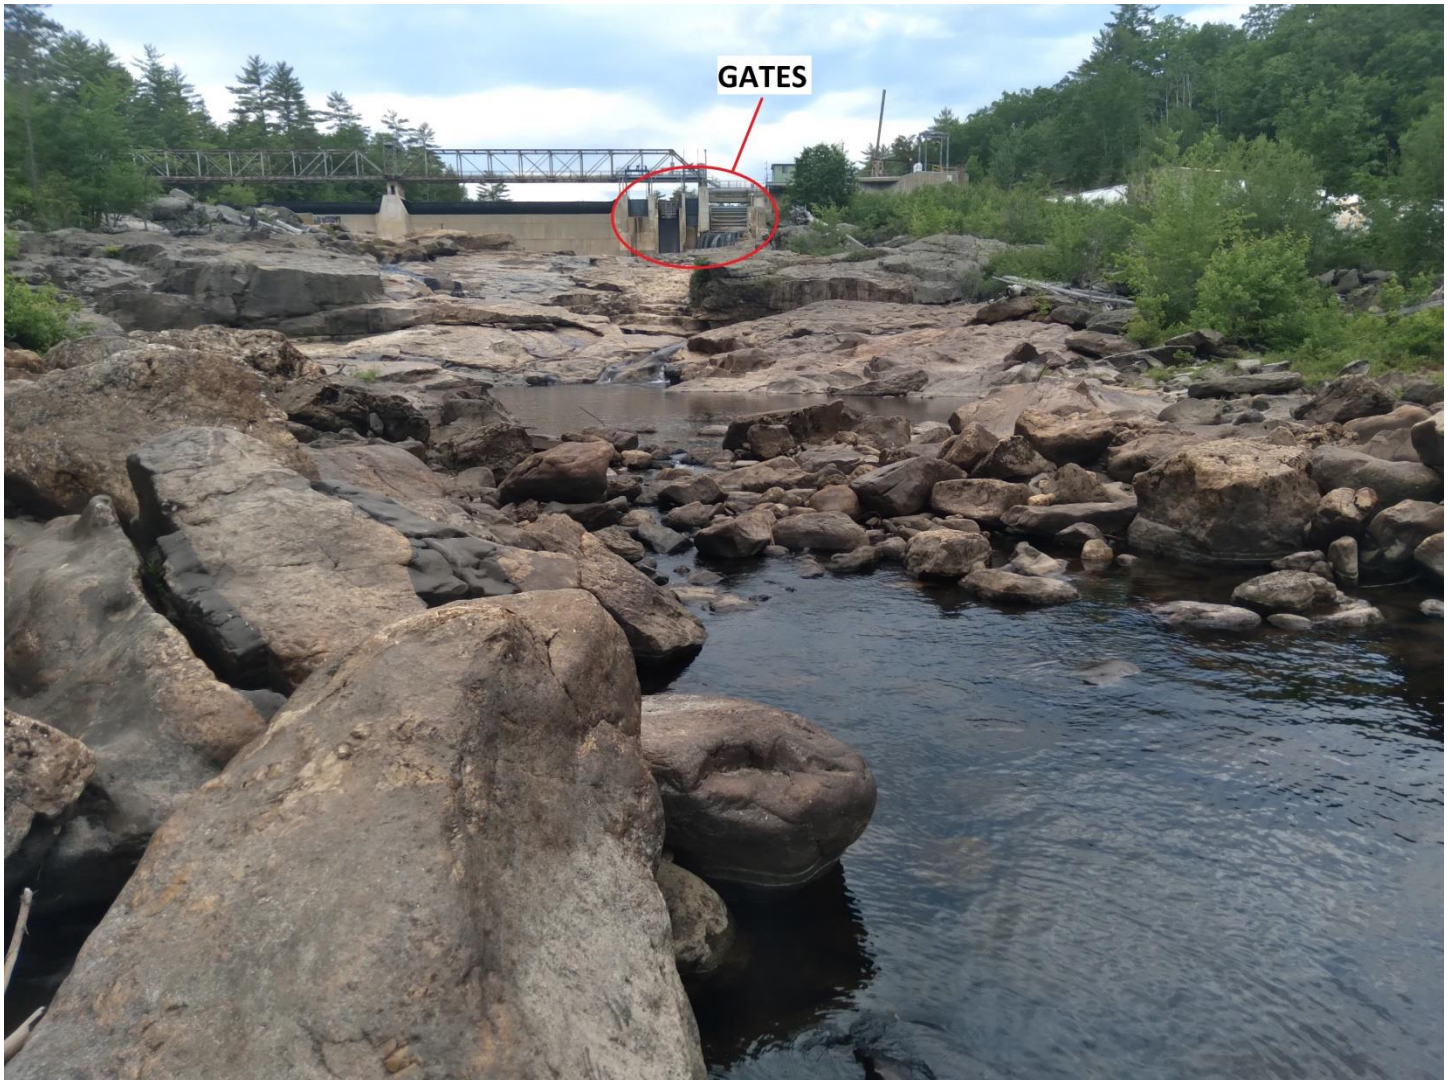
Photo 1, East side 1: This photo shows the east side of the 500-foot long cascade below Hiram Dam, which is dewatered 8 ½ months out of the year, viewed from the downstream end of the cascade. The photo demonstrates that the grade of the cascade is not steep. At moderate flows, it is easily walkable and fishable (I walked around this area with little effort), and passable by any variety of fish species. It is what fisher men and women would call “pocket water”, if it were not dewatered. MDEP’s analysis concluded that the cascade below the dam does not contain aquatic life, based apparently on a review of this section of the cascade. It can be clearly seen that the reason this section of river is devoid of sediment, vegetation, and related aquatic and terrestrial life is that it is in direct line of the narrow dam gates and the excessively high flows that occur when large releases are made, scouring everything but the larger stones out of the water’s path in this narrow channel. If those large flows were moderated and/or distributed across the full width of the cascade, the scouring effect could be mitigated, and if steady flows of 300 cfs were distributed continuously across the full width of the cascade, this scoured out section would recover appropriate sediments and aquatic plants to support a variety of aquatic life. Instead, this section of river is allowed only leakage flows of 2 cfs during 8 ½ months out of the year, interspersed with occasional concentrated, high velocity, destructive flows of water. In short, it is not anything in the nature of the landscape that has made this section of river devoid of life, but rather the operation of the dam itself.

There is value in the dewatered reach below Hiram Dam that is being minimized and ignored by the Draft Water Quality Certifications. On June 8, 2021, Sebago TU Conservation Committee member Matt Streeter visited the Hiram Dam site in order to photograph conditions. Some of these photos have been attached, along with detailed descriptions, as Attachment I. The photos demonstrate the following:

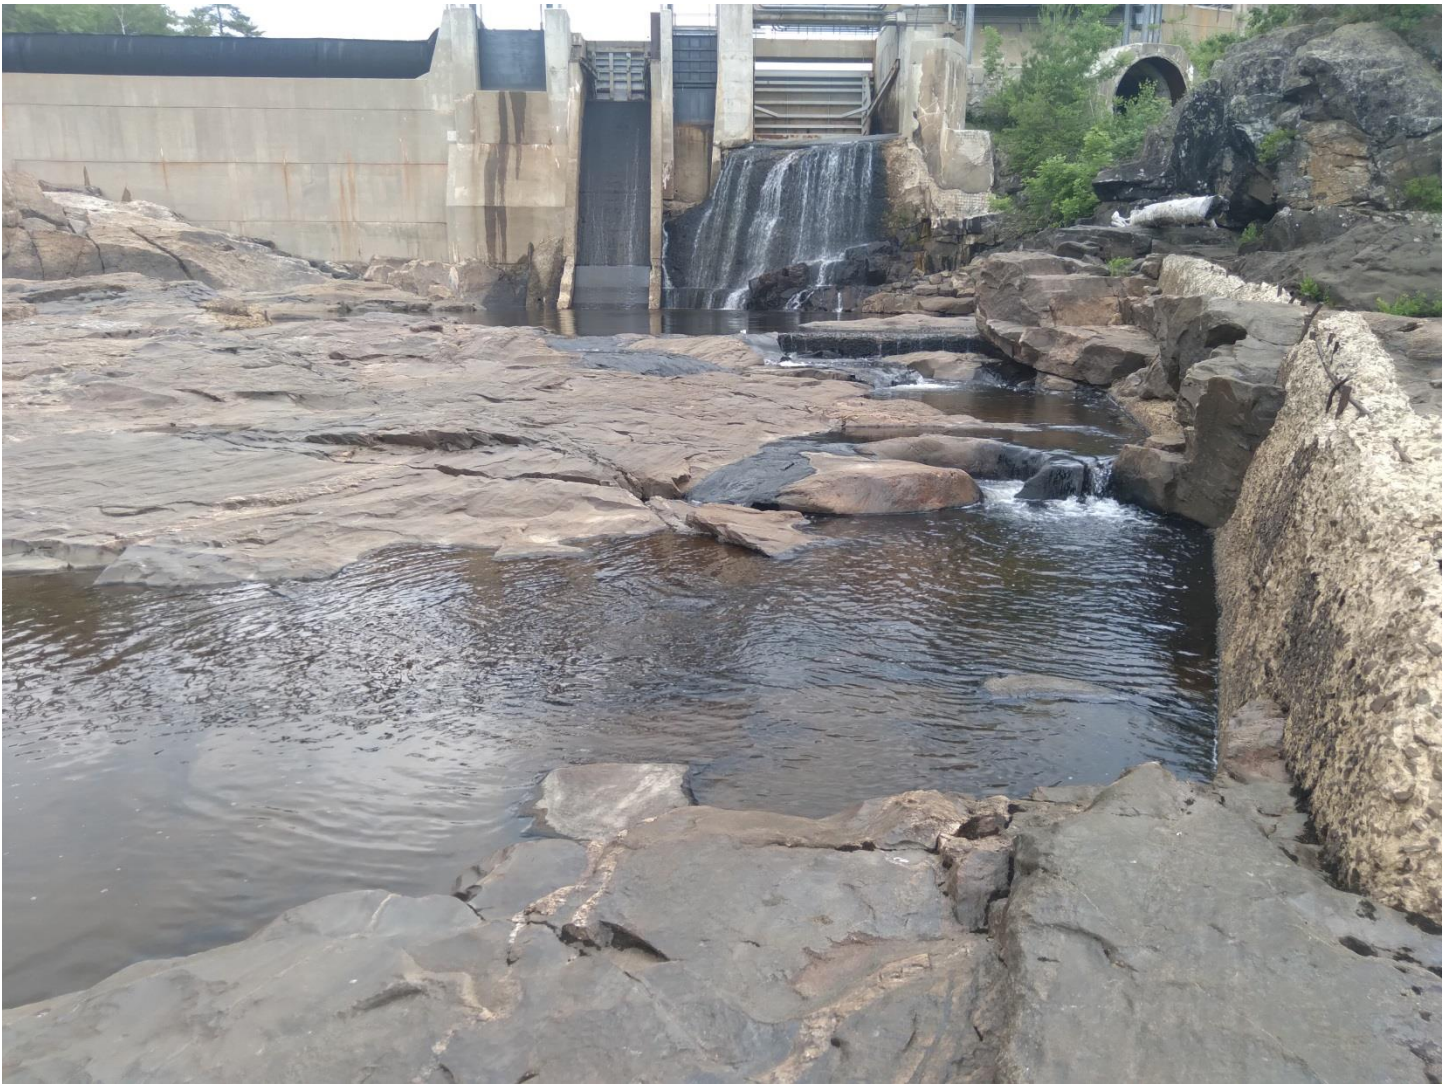
Photo 2, East side 2: This photo shows the gates up close, with about 100 feet of river bottom. It demonstrates all the more starkly the scouring effect of releases from the dam gates on the substrate of the river in this section.

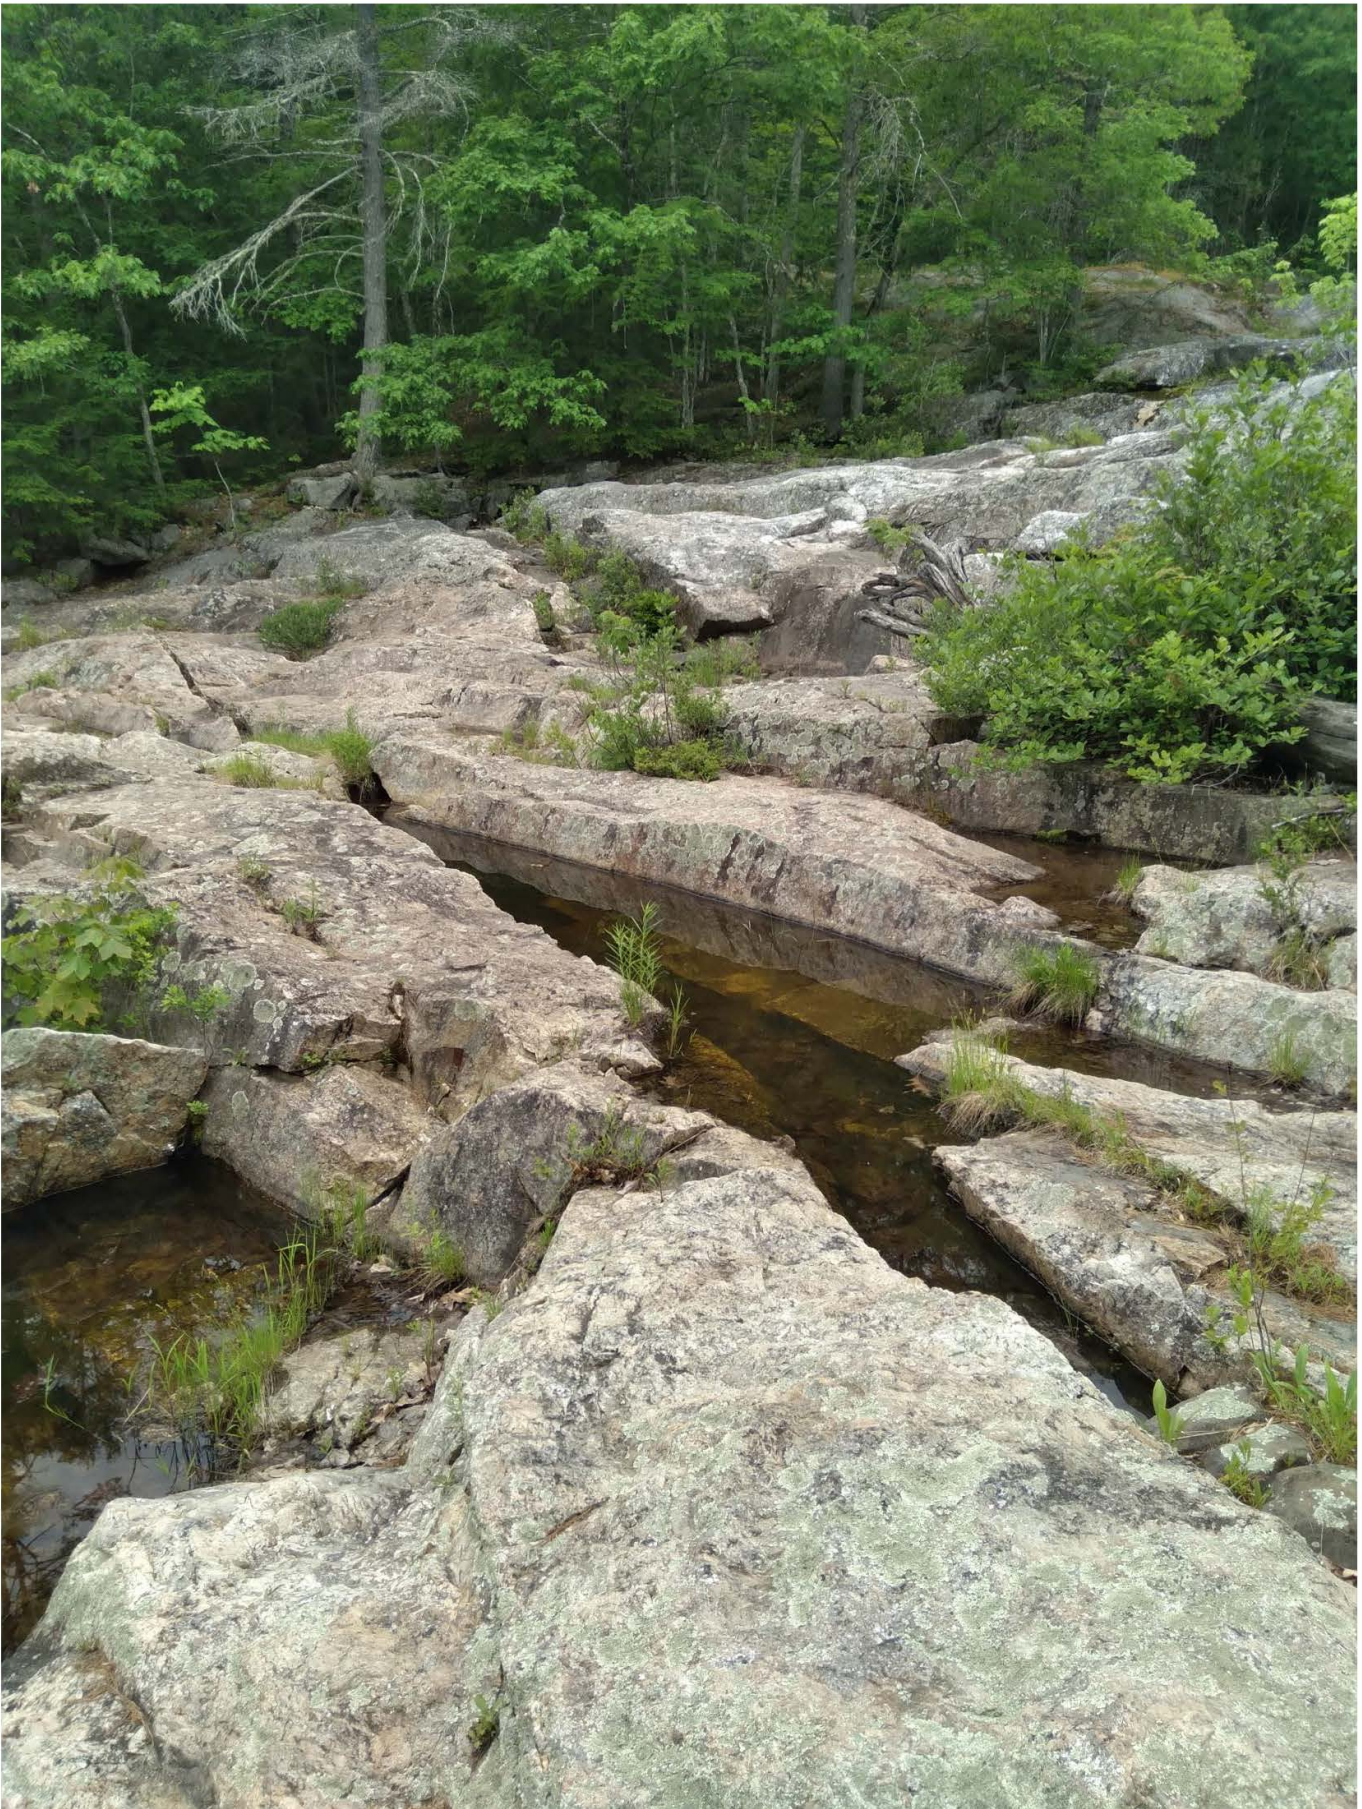
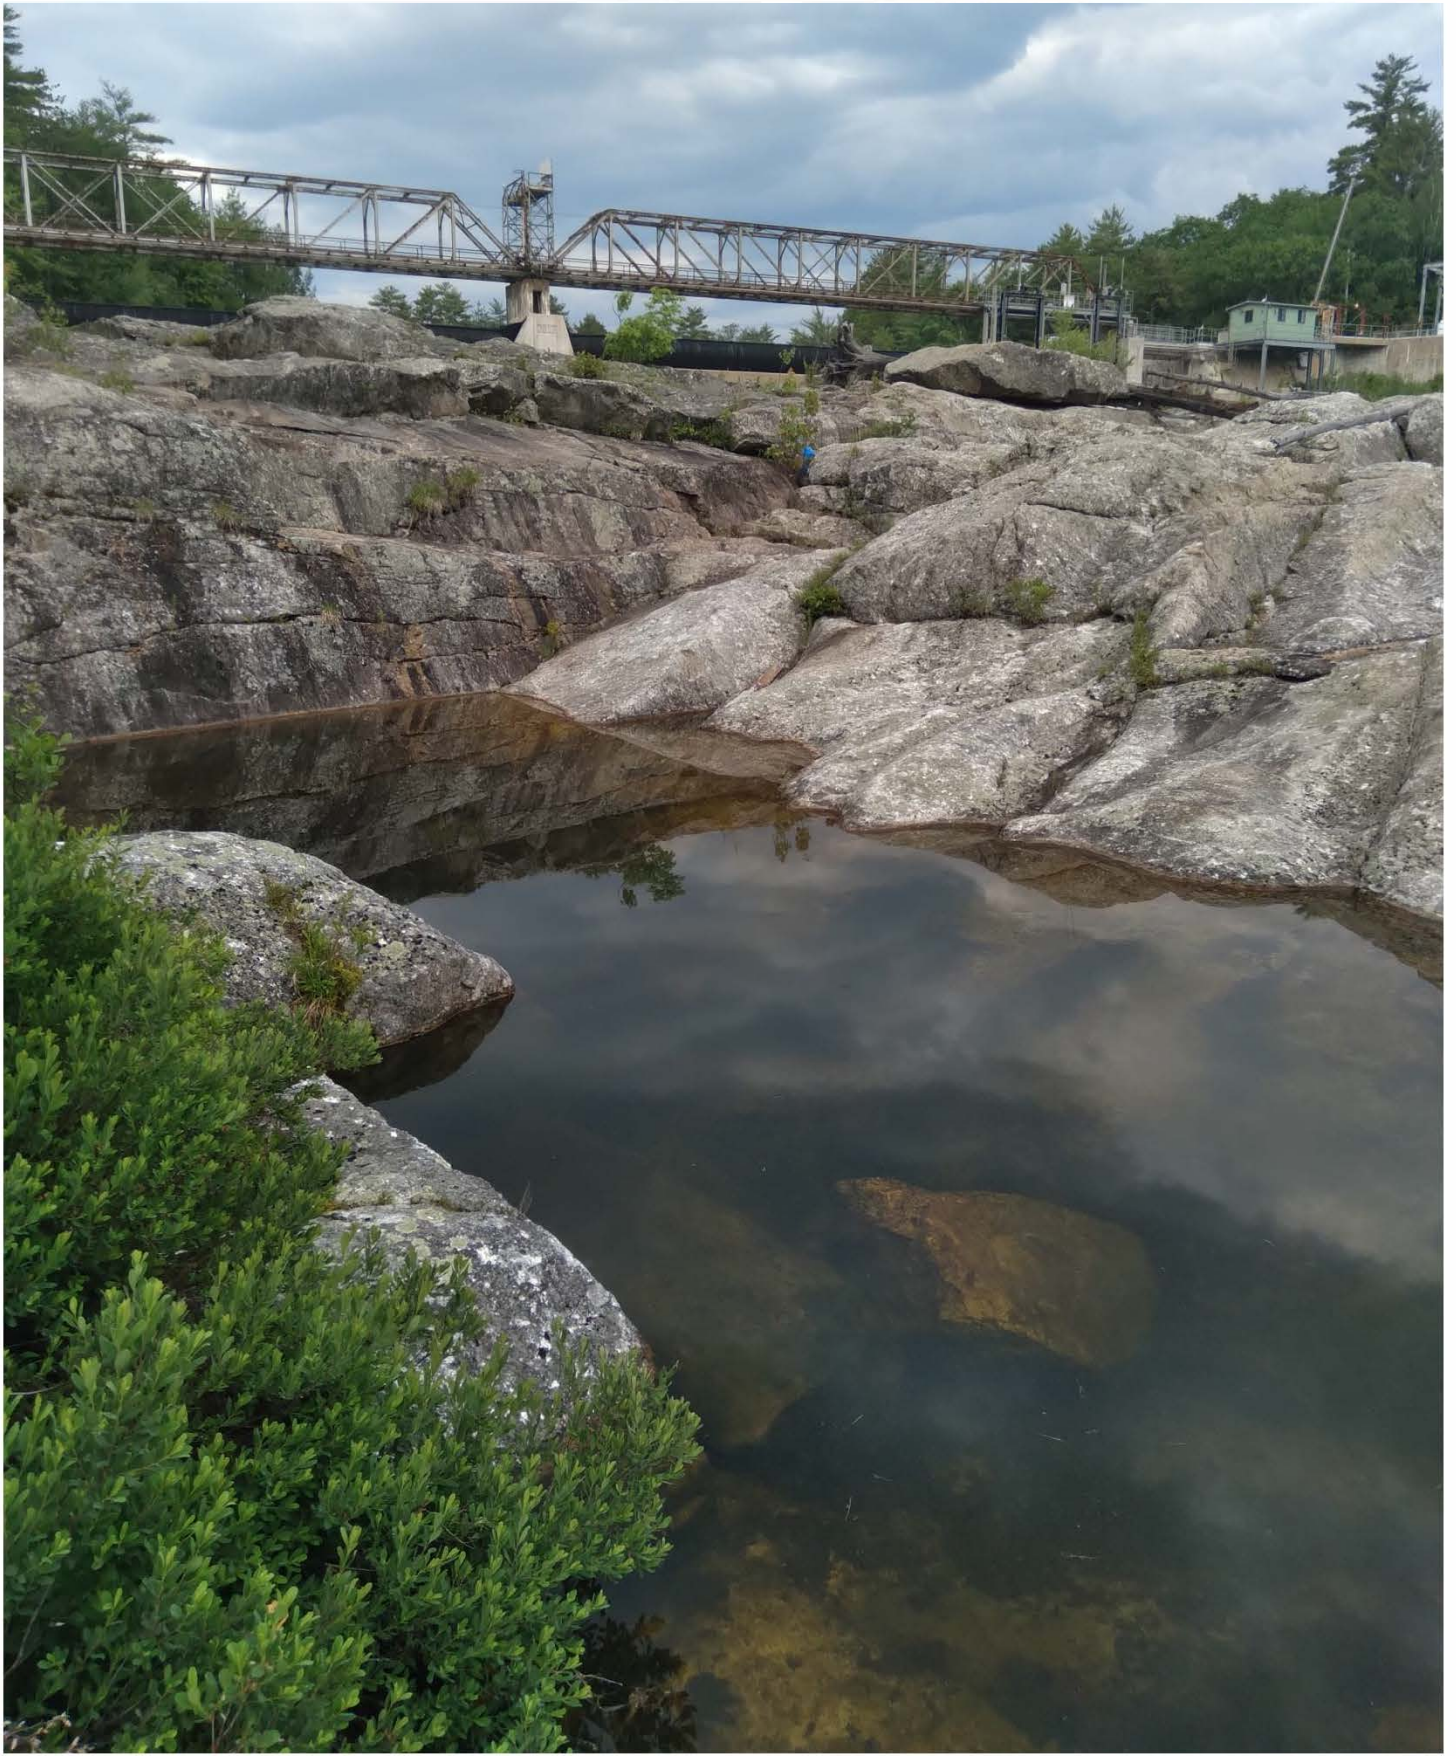
Photos 3 & 4, West side 1, West side 2 (above): These photos are characteristic of the west side of the cascade, which is not subjected to the concentrated flows of dam releases. Though dewatered, the pockets in this section at the time these photos were taken contained water and retained aquatic plant and animal life including algae, aquatic insects and tadpoles. Sand and gravel is abundant, and riparian plant species are present. As on the east side, the grade is moderate and with a modest flow would be passable by most fish species. This is attested by the comments of Bruce McLaughlin (Attachment L), a fisherman who fished this section of cascades from its base to the toe of the dam on a regular basis from the early 1980's through 2008. According to McLaughlin, "At that time, there was a fair amount of water flowing over the entire dam". Along with many other fishermen and women for whom Hiram Falls was a destination fishing spot at the time, he "fished all of the pools, starting at the upper ones just below the dam. There we caught decent sized brook trout, and as you descended the rock face to the lower pools and area across from the power house we caught pickerel, fallfish, brown trout, eels and bass". Even in the photos of this dewatered section, any fisherman or woman would recognize that this would be an abundantly populated section of river if it were not dewatered 85 percent of the time.

- 3) That by contrast, the west side of the cascade, spared the damage caused by dam releases, sustains basic aquatic plant and animal life and riparian vegetation, which could be a great deal more varied and abundant if minimum flows were directed over the full width of the dam, and high velocity flows from gate releases were kept to a minimum.

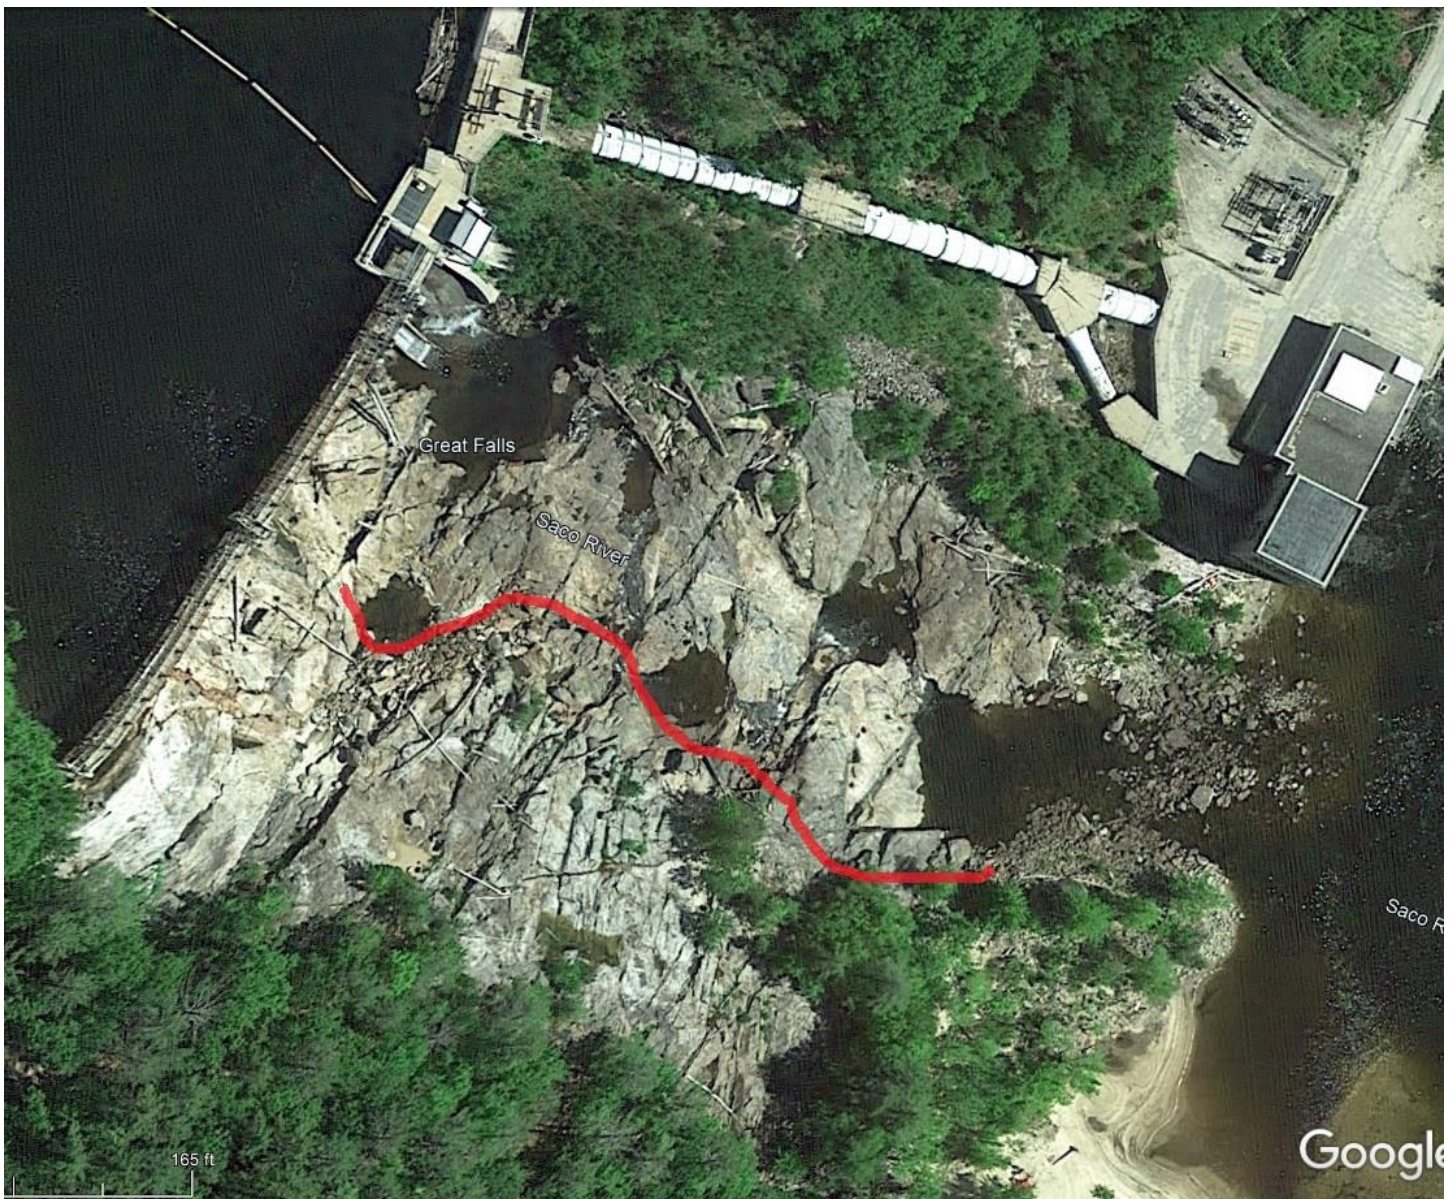
Photo 5, Google Earth Satellite view: Like the other photos, this satellite view of the cascade serves to show that the grade in this section of river is far from being too steep to sustain aquatic life and fish habitat. It also demonstrates the dramatic difference in habitat on the east side (top of photo) and the west side (bottom of photo), with the red line roughly demarcating the two sides. The east side, where the high velocity gate releases periodically scour out the channel, there is no woody debris, no mid-size boulders, and no terrestrial vegetation. On the west side, all of these elements are present. In fact, from ground level it is apparent that the river channel extends some distance under the tree canopy.
